Fisher & Paykel Drain Pumps

Fisher & Paykel Clip to Bowl drain pump.

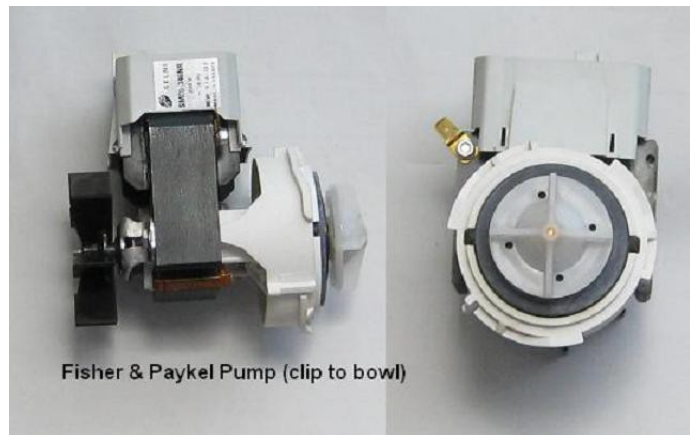
Illustration 1: FP005

Original pump specifications are:

Selni Pump SM00-246NR

230V 50Hz

80W, 0.7A

Made In France

Part Number 420324P Or FP005

These pumps usually only need to be cleaned, but if they use too much current and run very hot they need to be replaced. Measure the pump current using an inline ammeter (Appendix 1 **). It should be between 0.6 to 0.8A. If it uses 1.0a or more it should be replaced. Alternative, the resistance should be 33Ohms.

The pump can fail in 3 ways, The winding can fail, and may have discoloured windings and the pump will use more than 0.8A. In coastal areas, the join in the laminations can corrode causing excessive motor current. The seal between the pump and the motor wears and leaks, if left long enough it will cause the winding to fail. The leaking seal is evidence by slug on the motor side of the seal. Try and make one good pump out of two.

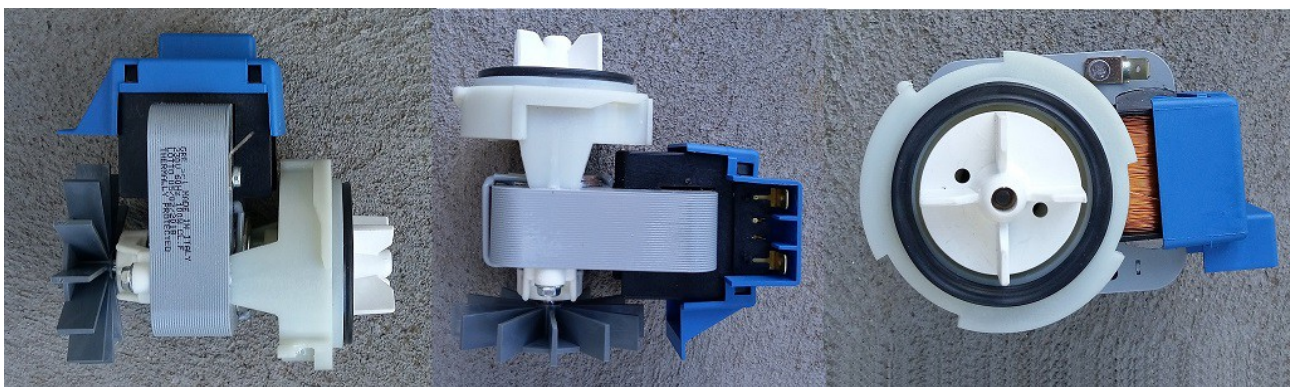
Illustration 2: FP005 Substitute pump

1. Used pump. These are tested and use 0.8a or less and have no sign of water leaking through the seal.
2. Substitute pump. These have a Hoover motor with a FP clip to the bowl end on them. They work well on the early PCB (Blue, Green, Yellow but may have problems with the Gray and Brown PCB with surface mount component. They have different resistance.

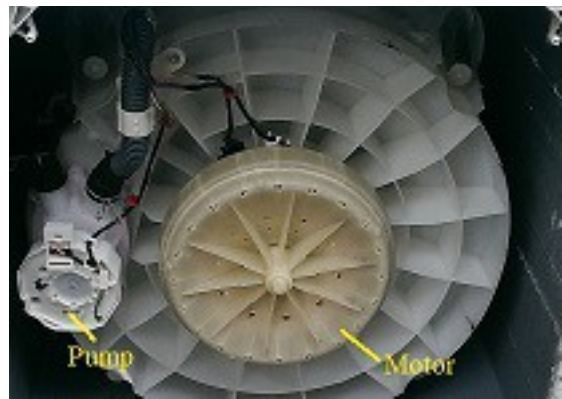
Illustration 3: Inverter Pump

Replacement not recommended. When the pump blocks it takes out the main PCB (fails in a thin track/fuse plus other components). Best to cut looses! The idea was good to use a high-efficiency motor but the design was lacking. FP quickly replaced the pump on the next model with the synchronous pump. See below .

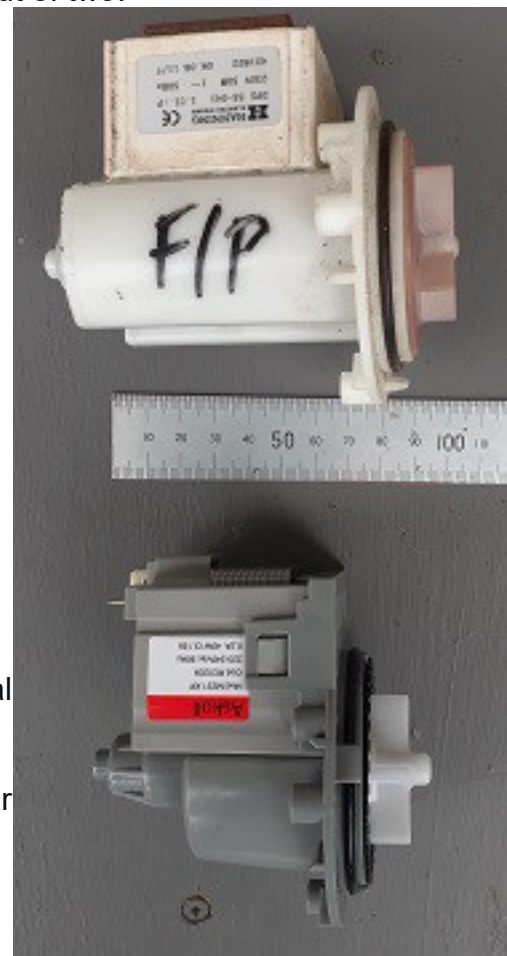
Illustration 4: Synchronous Pump
Top F/P pump, Bottom UN1087

The synchronous pump or magnetic pump are now used on the later model washers. (check under the washer!) they use a slightly larger pump, but a universal pump can be fitted with no problems. It will have enough power and will last long enough. A UN1087 screw-on pump is a replacement. LG has done a similar thing.
